Hydrology of the November 2005 Floods

Dr David Kemp

Department for Transport, Energy & Infrastructure

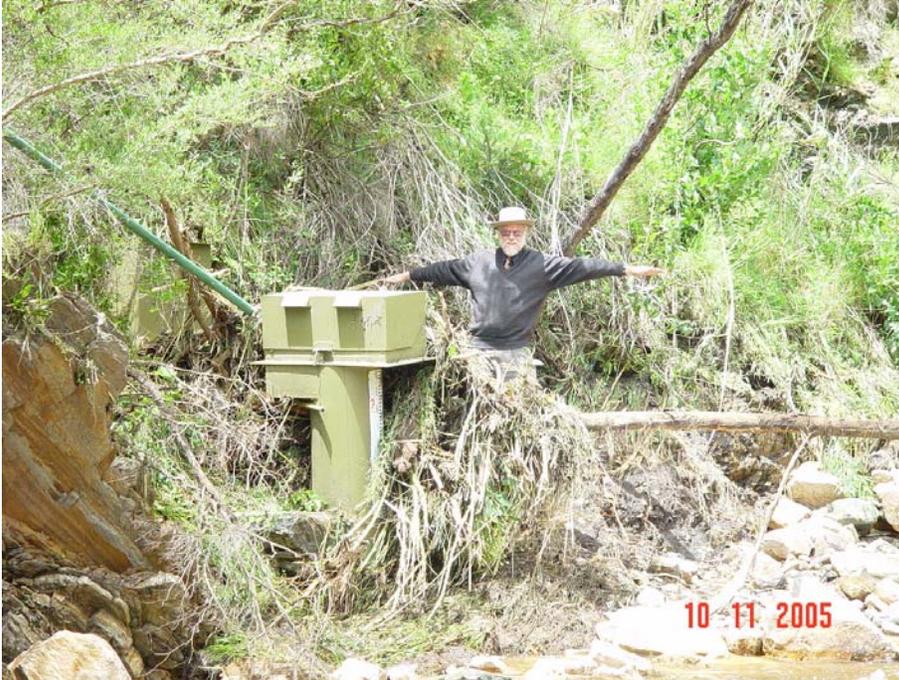
There is a need to visit the gauging stations as soon as possible after a major flood, to confirm the peak level, and thus flow. A visit two days after the flood showed the cause of the problem with the First Creek hydrograph (Figure 3). Even if the hydrograph is apparently good, there can be a problem. This was the case on Fifth Creek, where the recorded peak level was different to the measured peak level.

Figure 3 First Creek Gauging Station Above the Waterfall - Author Showing Peak Water Level

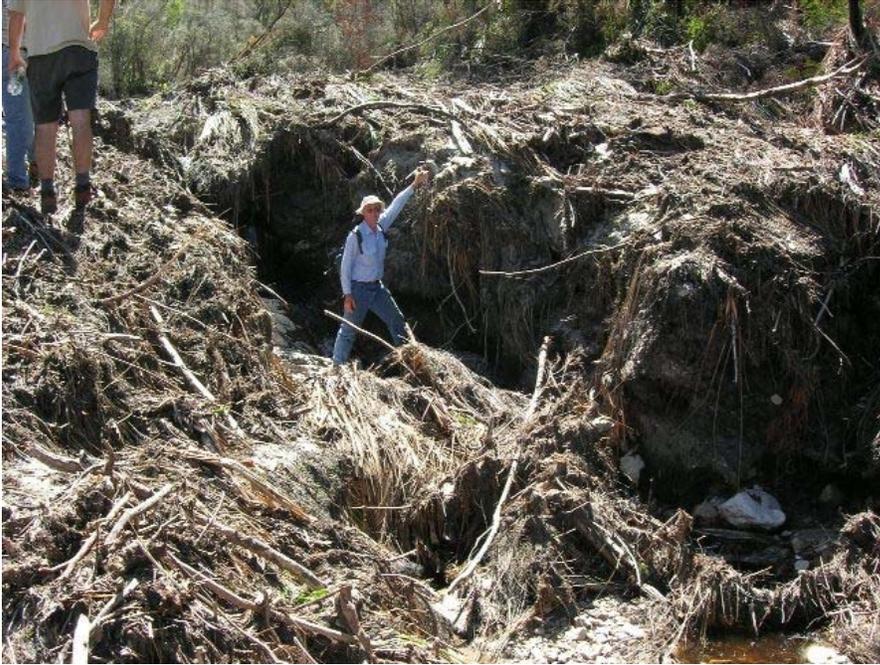
Investigation within the catchment revealed that there had been a substantial amount of erosion, and indeed a mass failure in the sediments that made up Wilson's Bog.

Figure 6 Erosion in Wilson's Bog, First Creek Catchment

The failure of Wilson’s Bog represented mechanism by which floods much larger than expected with normal runoff processes could occur, and it was necessary to obtain more information on the causes and likelihood of the mechanism. A report by a geomorphologist was commissioned, that gave more information on which to base an assessment of the ARI of the November flood. It is now thought that the most likely ARI of the flood in Waterfall Gully was 100 years. However, since the catchment above the waterfall only contributes a minor amount to the creek within the urban area, and the rainfall was a lot lower on the plains, the ARI of the flow in Norwood to the Botanic Gardens was only of the order of 10 – 20 years ARI.

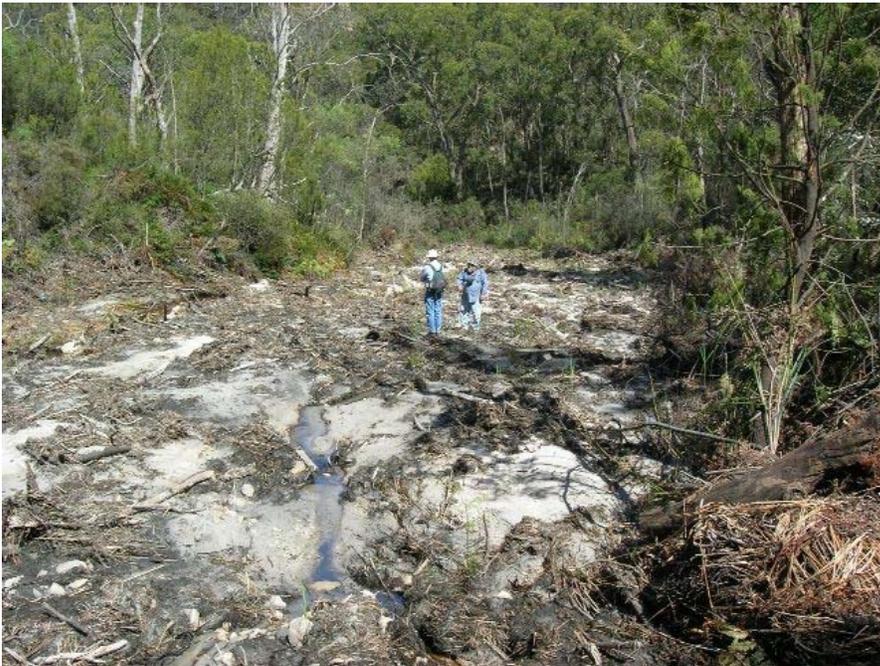
Figure 7 Wilson's Bog, First Creek Catchment
